Final Report on Life Testing of the Vapor Compression Distillation/Urine Processing Assembly (VCD/UPA) at the Marshall Space Flight Center (1993 to 1997)

P. Wieland, C. Hutchens, and D. Long

Marshall Space Flight Center, Marshall Space Flight Center, Alabama

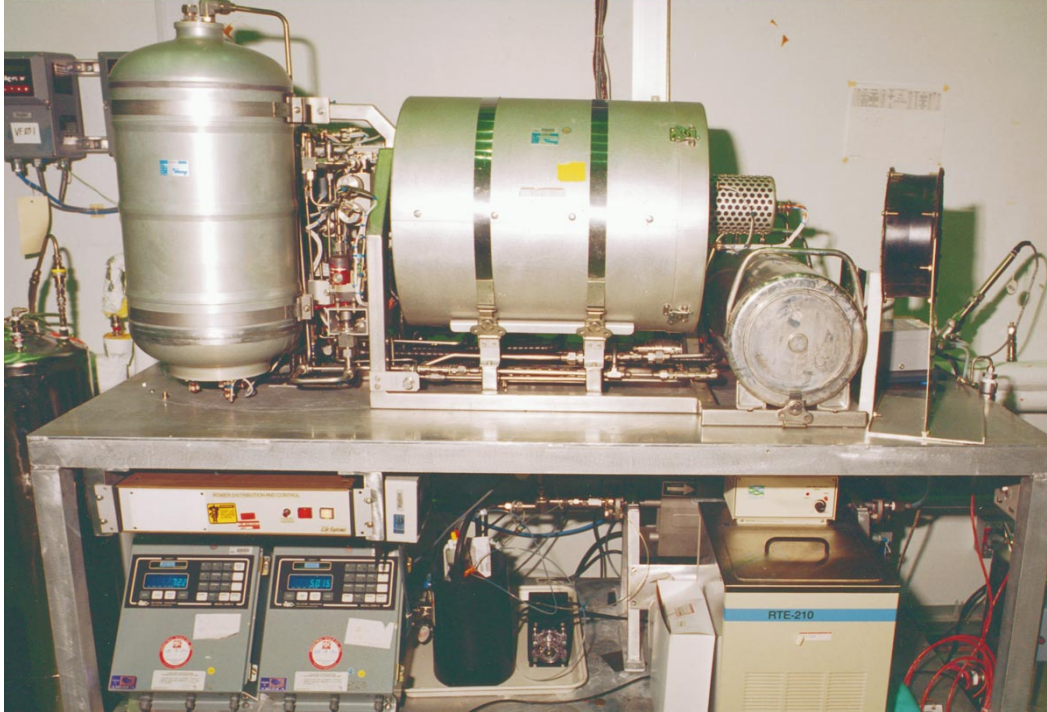
Figure 2. Photograph of the VCD-5.

Photographs of the VCD-5 and VCD-5A are shown in figures 2 and 3. As shown schematically in figure 4, the VCD-5 and VCD-5A each consist of a wastewater storage assembly (WSA), a fluids control assembly (FCA), a fluids pump assembly (FPA), a distillation assembly (DA), a recycle filter tank assembly (RFTA), a pressure control assembly (PCA), a purge pump assembly (PPA), and sensors for measuring conductivity, temperature, pressure, rotation speed, and electrical current level. These components are described below.

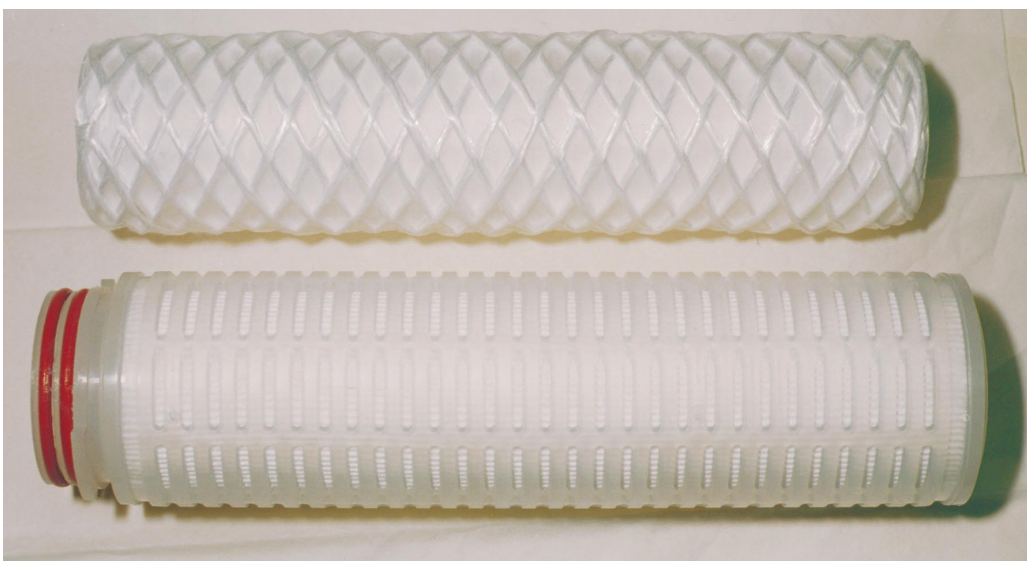
Figure 8. VCD/UPA filters (top: 25 μm pore size, bottom: 10 μm pore size).

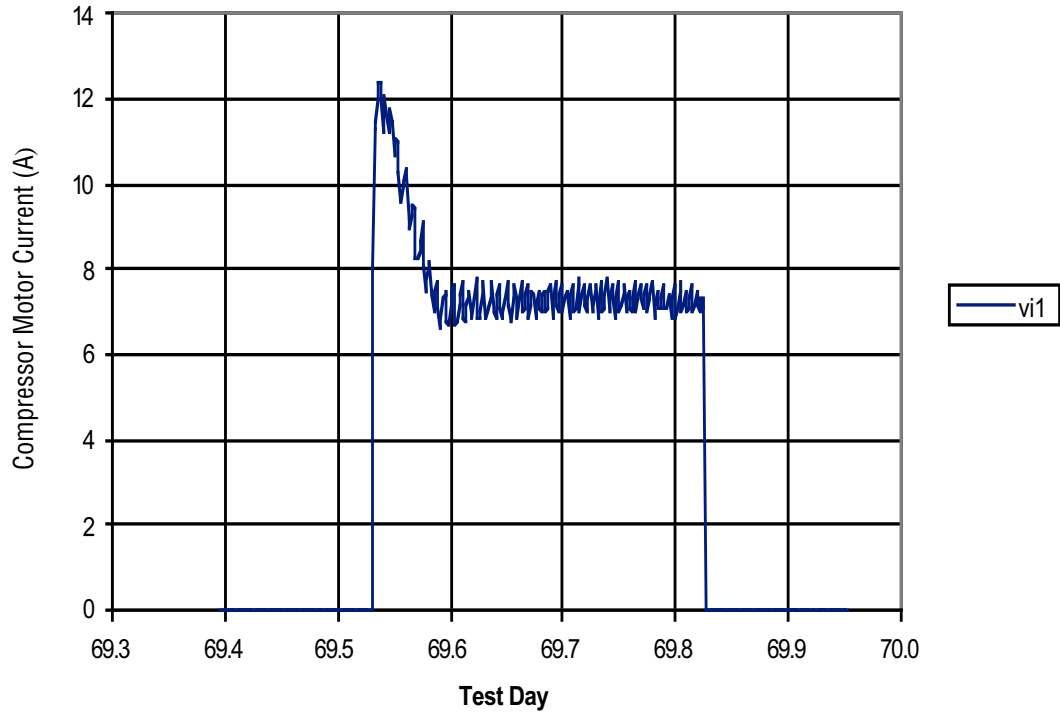
Figure 16. VCD-5 typical compressor motor current (I1).

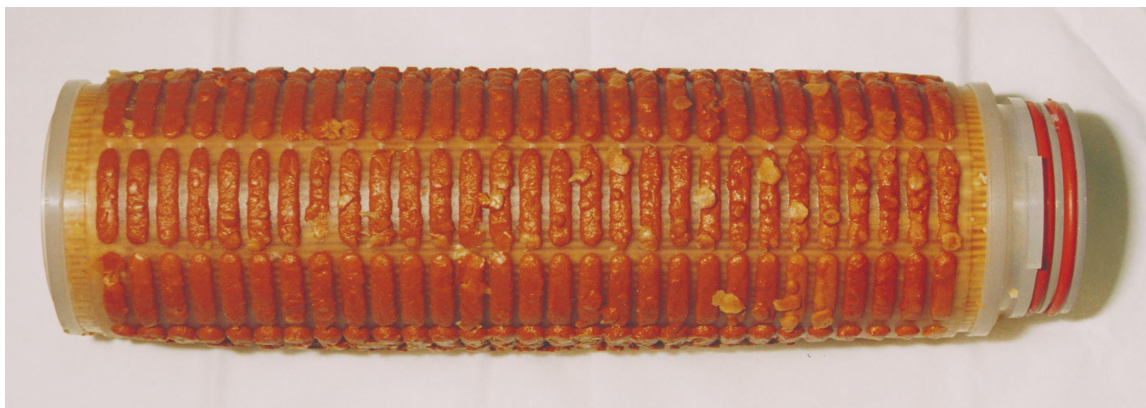
Figure 18. VCD-5 10 µm pore size filter used during WRT Stage 10.

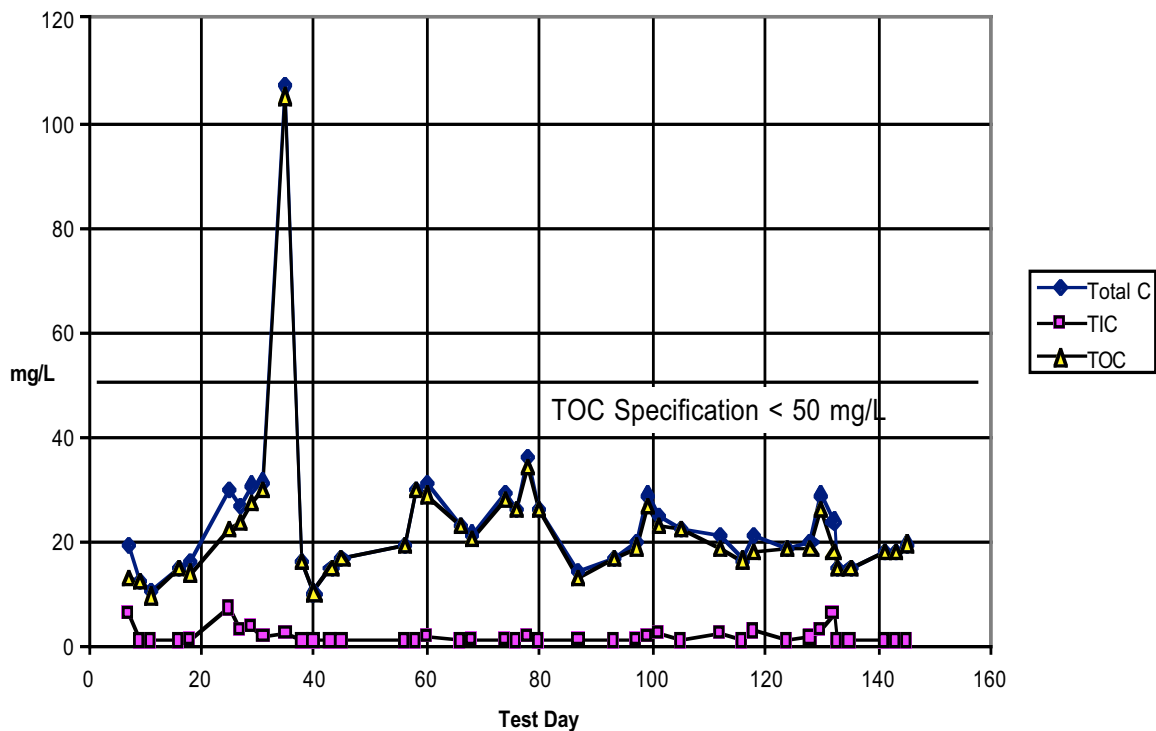
4.4.2.3 VCD-5 Product Water Quality. The water quality specifications and average water quality data for the VCD-5 distillate are shown in table 10. The TOC, total inorganic carbon (TIC), and total carbon are graphed in figure 28. In general, the water quality was considered nominal for the VCD-5, and was well within the specified level. The only exception was on test day 35 when the TOC reached 105 mg/L. The reason for this may be related to the mechanical problems experienced on that day due to wear of the Vespel® gear. As shown in figure 26, the pH and conductivity are well within specification, with the only exception on test day 35 when the conductivity reached 246 $\mu\text{mho/cm}$. On test day 133 the pH showed a spike to 7.2. The reason for this has not been determined. No differences in water quality were attributed to adding CHeCS water or to the urine pretreatment tablets, although the average conductivity was about 12 $\mu\text{mho/cm}$ higher than for Stage 9, and higher than the 40 to 60 $\mu\text{mho/cm}$ (occasionally above 70) during life testing in 1993 and 1994. Even so, the average conductivity was well below the *ISS* specification of 150 $\mu\text{mho/cm}$ maximum.

Figure 28. VCD-5 product water carbon composition during WRT Stage 10.

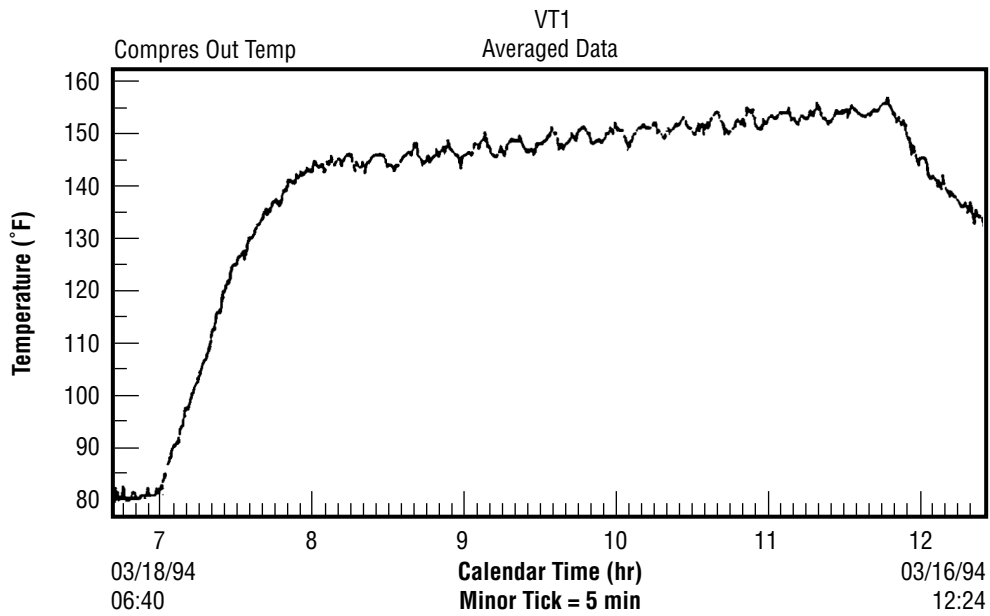
Figure 30. VCD-5A typical compressor temperatures (T1).

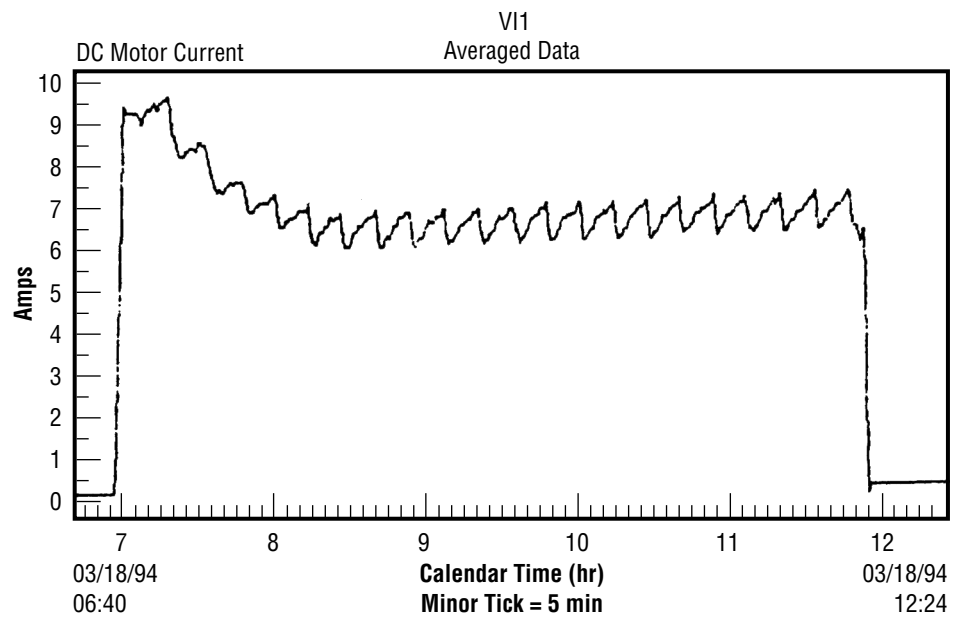
Figure 31. VCD-5A typical motor current (I1).

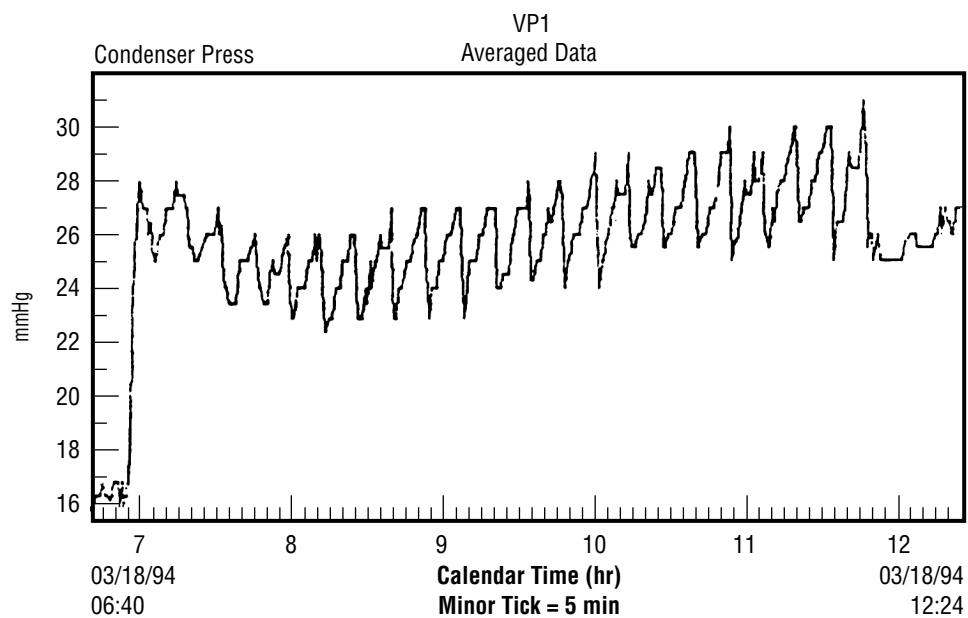
Figure 32. VCD-5A typical condenser pressures (P1).
